## Summary of FCI Score: Portfolio View

## Summary Of Recommendation:

This document is based on current conditions observed during a site visit and provides recommendations for corrective actions by each discipline as deemed necessary. The following recommendations provide a summary of the findings.

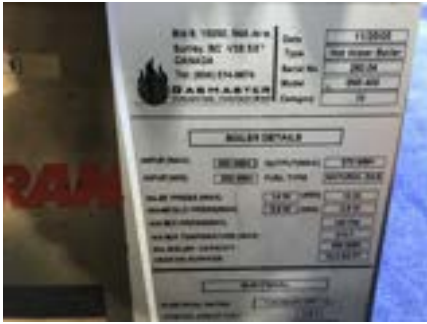
ACP-01

Type	Pump	Size	60,000 BTU
Category	HVAC	Installation Date	08/12/2010
Manufacturer	CANADA	Observed Remaining Life	8
Model	ABC123	Condition	Poor
Serial Number	19280527	Replacement Cost	\$12,055

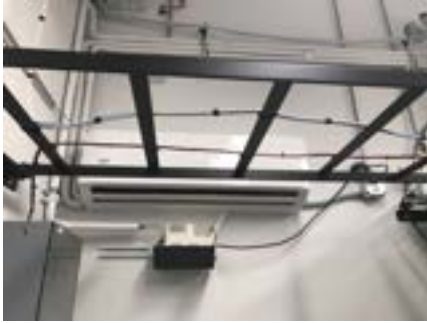
AC-1

Type	Air Conditioner	Size	7500 BTU
Category	HVAC	Installation Date	7/01/2020
Manufacturer	Carrier	Observed Remaining Life	12
Model	Not Accessible	Condition	Fair
Serial Number	55165551	Replacement Cost	\$7900.00

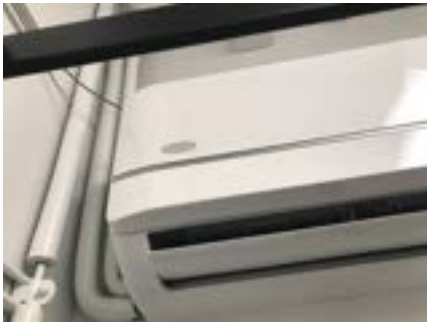
AC-1

Type	Air Conditioner	Size	5000 BTU
Category	HVAC	Installation Date	12/01/2017
Manufacturer	Carrier	Observed Remaining Life	12
Model	548855	Condition	Good
Serial Number	5515556	Replacement Cost	\$5800.00
