Memorial Healthcare

**Facility Condition
Report**

2025

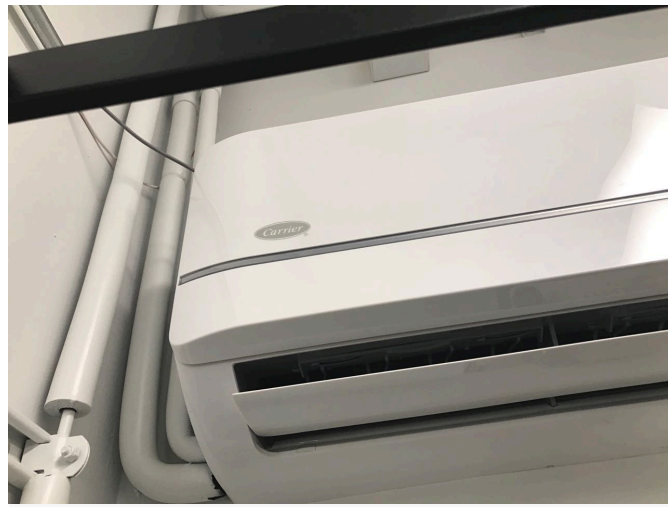
[AC-1 - Administrative Services](#)

Category: D30 - HVAC

Size: 10,000 BTU

Type: Air Conditioner

Installation Date: 11/2020

Manufacturer: Carrier

Observed Remaining Life: 12

Condition: Good

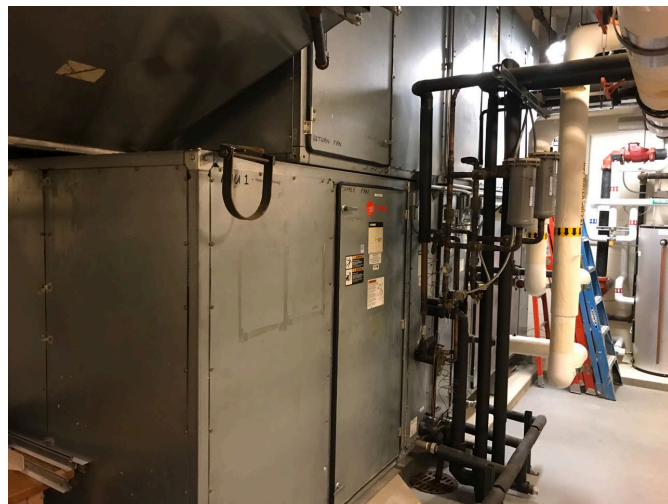
[AHU - Administrative Services](#)

Category: D30 - HVAC

Size: 50 Ton

Type: Air Handling

Installation Date: 05/2010

Manufacturer: Carrier

Observed Remaining Life: 10

Condition: Fair

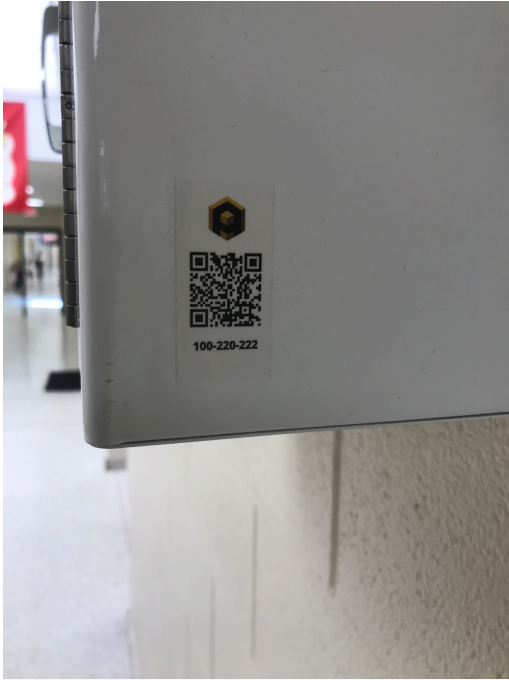
AED-01 - Clinic North

Category: D40 - Fire Protection

Size: 100 Gal

Type: Pump

Installation Date: 10/2010

Manufacturer: HeartSine

Observed Remaining Life: 6

Condition: Fair

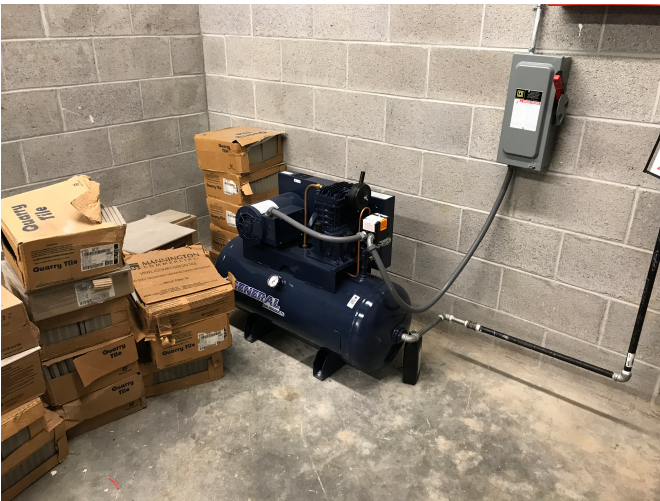
ACP-01 - Clinic North

Category: D30 - HVAC

Size: 50 Gal

Type: Pump

Installation Date: 11/2000

Manufacturer: CANADA

Observed Remaining Life: 8

Condition: Poor

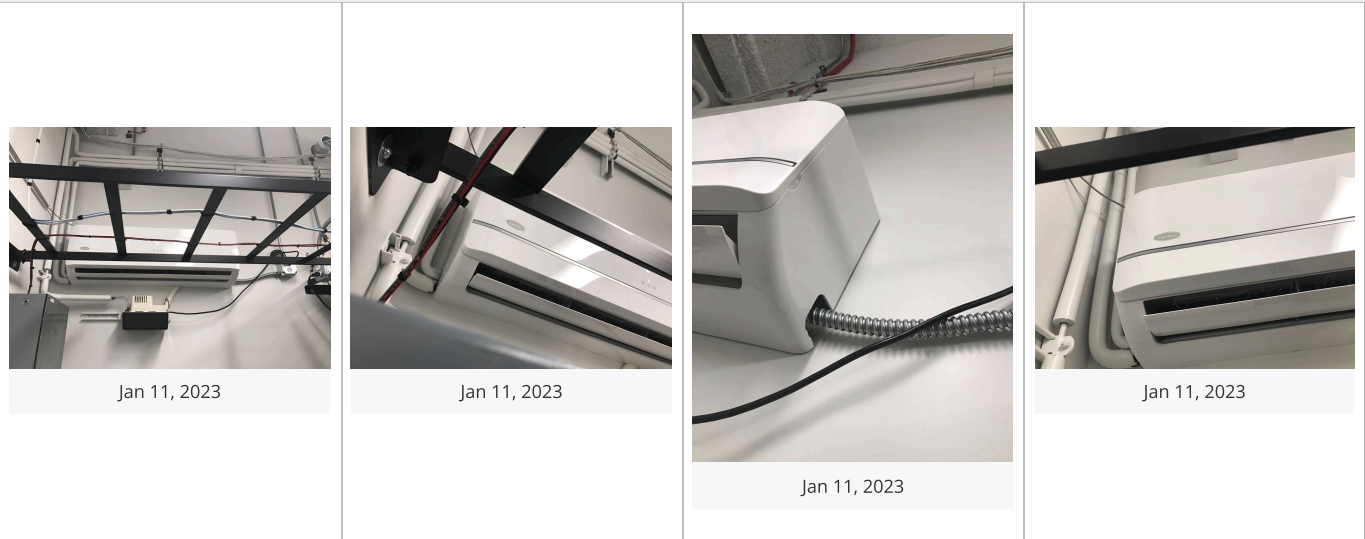
AC-1 - Administrative Services

Category: <i>D30 - HVAC</i>	Size:
Type: <i>Air Conditioner</i>	Installation Date:
Manufacturer: <i>Carrier</i>	Observed Remaining Life: 12
Model: <i>Not Accessible</i>	Condition:
Serial Number:	Cost: \$51700
